1. Executive Summary

The October 8, 2022 allision of the vessel MT Tradewind Passion with the Demerara Harbour Bridge (DHB) resulted in extensive damages to critical components of the bridge as a consequence of which the bridge was rendered inoperable, and serious physical injuries were sustained by an employee of the DHB Corporation.

2.1 Damage to the Demerara Harbour Bridge

2.2 Damage to the Tradewind Passion

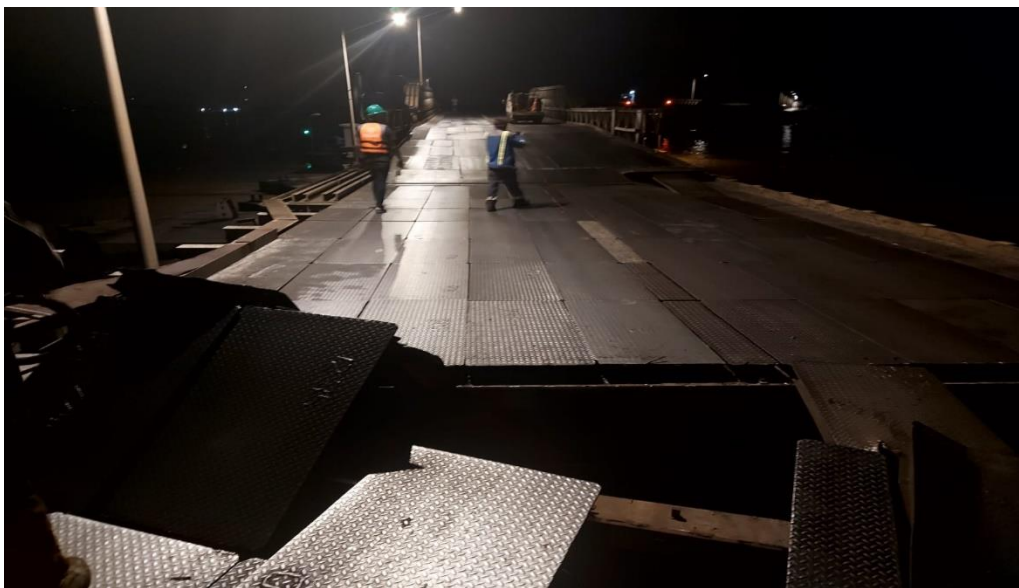
Based on the initial assessment done by the DHBC, the collision of the Tradewind Passion with the Bridge resulted in severe damage to the bridge infrastructure at spans 7,8, 9, 10, 11 and 12. Some of the recorded damages are as follows:

- mowed down 2 sets of 15 piles clusters on the north western side of the bridge;
- damaged the pontoon, king post and panels at span 9.2;
- damaged the special connecting posts at spans 7/8 and 11/12;
- severely damaged to the transom beams at spans 7/8 and 11/12 as well as the transom beam under the ramp;
- damaged about 15 anchor blocks
- both eastern and western sections of the bridge were forced out of original alignment at approximately 45 degrees southwest, and northeast, respectively.

Image 1 - The damaged deck plates of Span 8

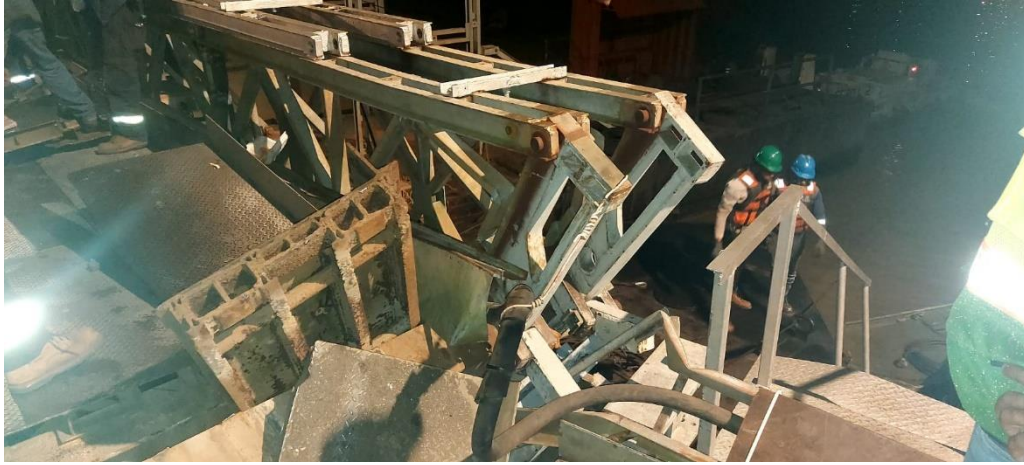
Image 2 - Damaged section of truss deck on Span 8

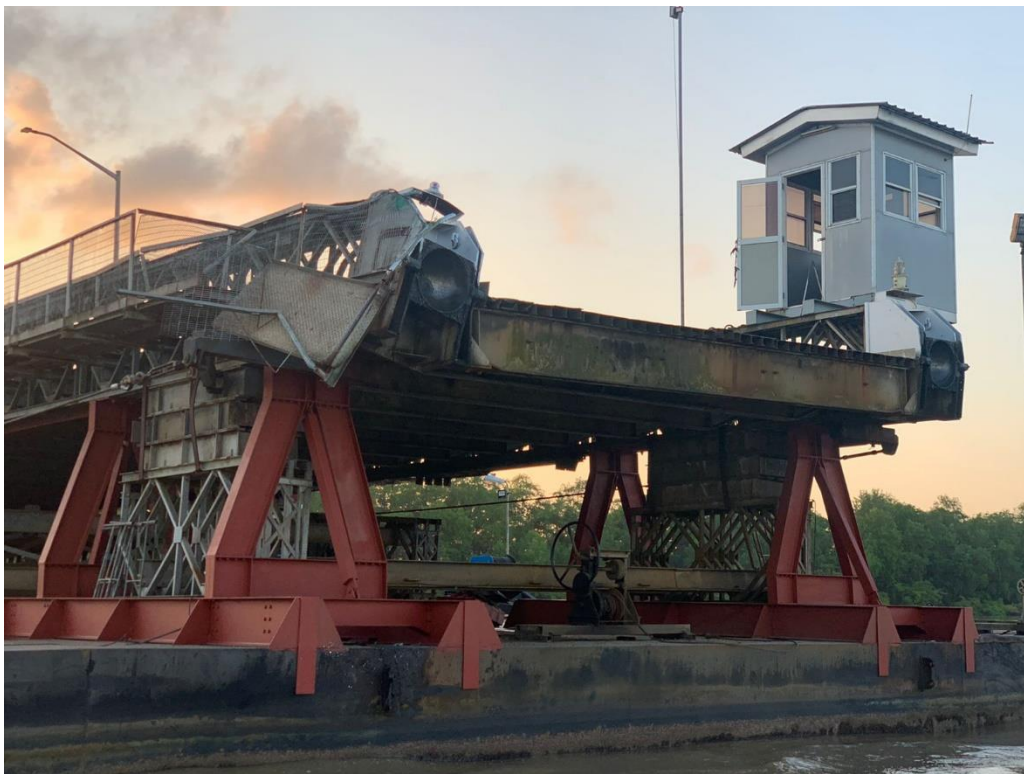
Image 3 - Damaged section of the retractor span

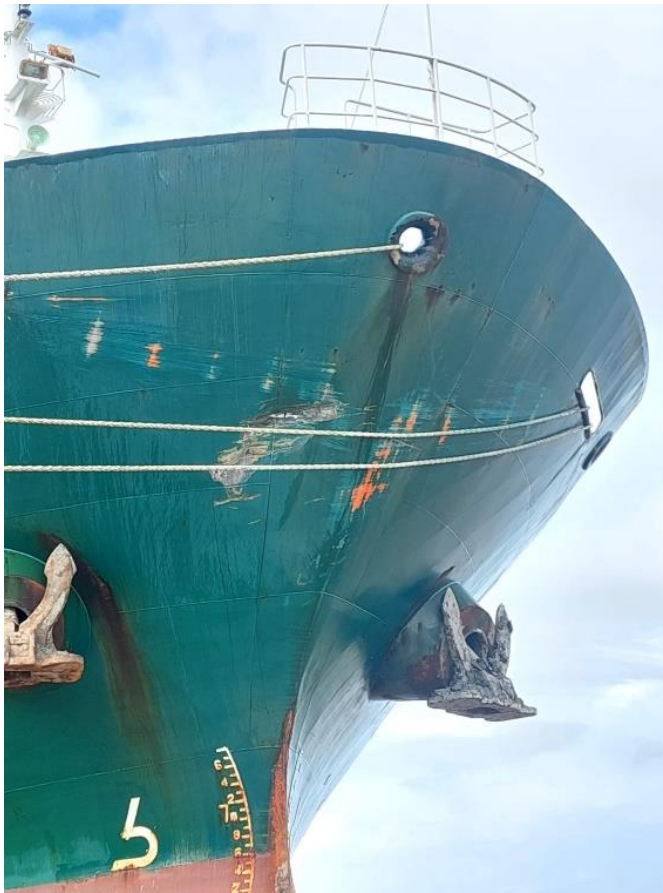
The damage to the Tradewind Passion was observed by members of the Board of Inquiry when a visit to the vessel was done on October 10, 2022 at the Guy Oil berth, Providence, East Bank Demerara. Image 4 is a view of the damage on the starboard bow resulting from the impact with the bridge. Image 5 is the damage to the interior frame of the starboard bow.

Image 4 - Damage to the starboard bow of the Tradewind Passion

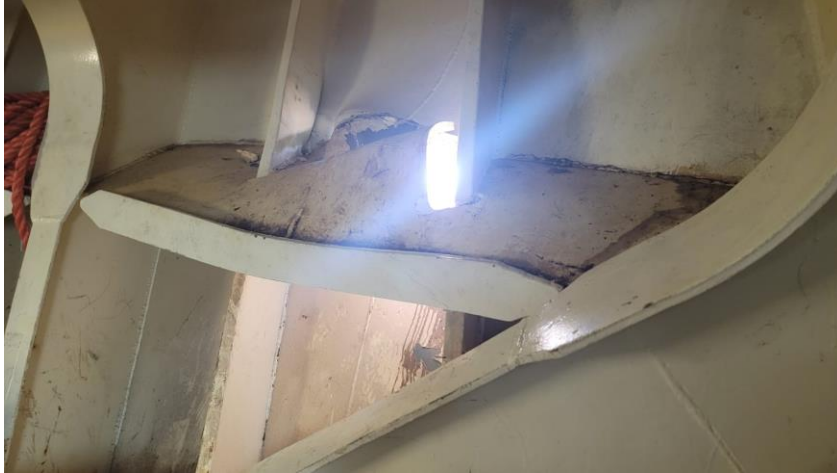
Image 5 - Damage observed from the interior frame of the Tradewind Passion
